Standard Specification CCTV Stormwater Inspections

PROJECT: **CCTV EXAMPLE**

Section Inspection - 10/09/2024 - MA1429-MA1428

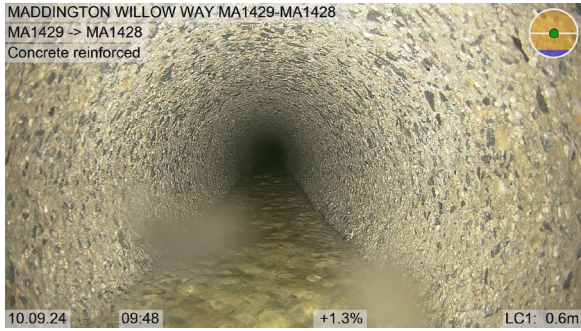
MA1429-MA1428_3eee685e-6986-445e-9e4d-76d4a8ebd707_20240910_094802_112.jpg, 00:00:00, 0.60
Start node, maintenance chamber, Nodename:, MA1429

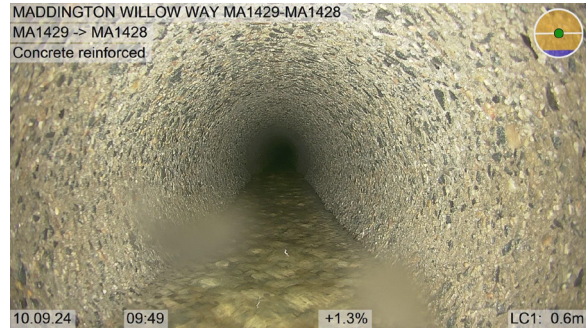
MA1429-MA1428_cd280af0-c390-4890-b992-abce1ba52fde_20240910_094932_976.jpg, 00:01:09, 0.60
Water flow at constant depth, clear water, 5-10%

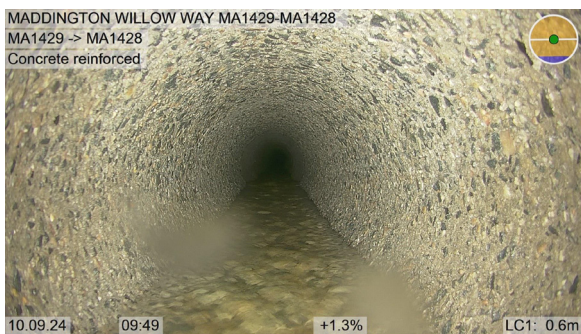
MA1429-MA1428_8d249dfc-b3f4-4b81-8e0f-8882d939a1de_20240910_094959_338.jpg, 00:01:11, 0.60
Surface damage concrete, spalling of the concrete conduit including localised chipping from 12 o'clock to 12 o'clock, Start

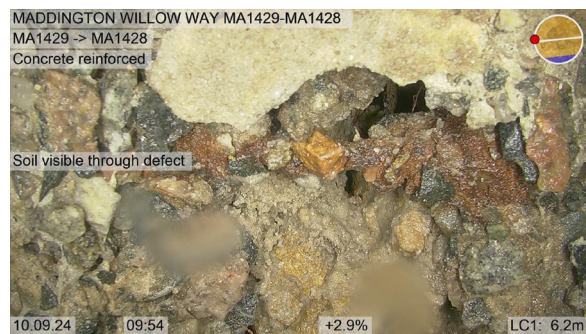
MA1429-MA1428_9c184860-22cc-4b3d-b5ed-2693c3d382c3_20240910_095434_344.jpg, 00:04:50, 6.20
Surface damage concrete, localised hole in wall at 9 o'clock

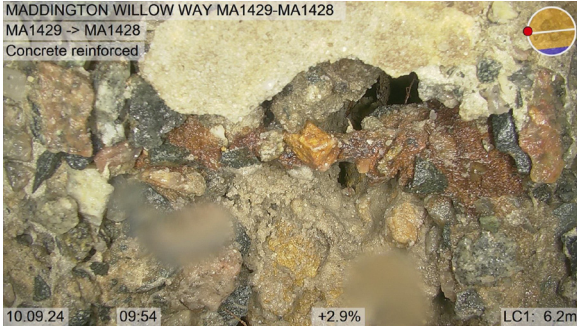
MA1429-MA1428_c759d337-2642-44e4-90c9-ec14f0bc887_20240910_095429_427.jpg, 00:04:52, 6.20
Soil visible through defect

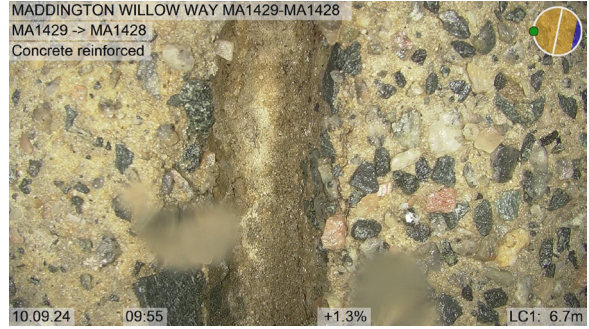
MA1429-MA1428_5b8eded4-5ad5-444d-8ca2-678f18c7794b_20240910_095537_607.jpg, 00:05:56, 6.70
Joint displaced longitudinally, 20mm

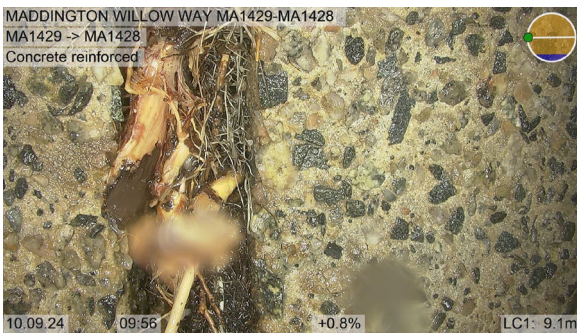
MA1429-MA1428_10a5535a-1a28-4794-907d-295de9346e48_20240910_095637_793.jpg, 00:06:40, 9.10
Recently cut interwoven mass of mostly fine roots leaving a beard of roots, Obstruction: 10%, at joint from 7 o'clock to 9 o'clock

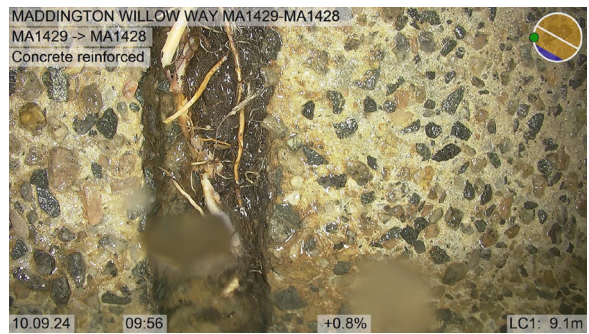
MA1429-MA1428_64e03d28-a118-4fe6-985b-aa2389376e7b_20240910_095642_755.jpg, 00:06:40, 9.10
Recently cut interwoven mass of mostly fine roots leaving a beard of roots, Obstruction: 10%, at joint from 7 o'clock to 9 o'clock

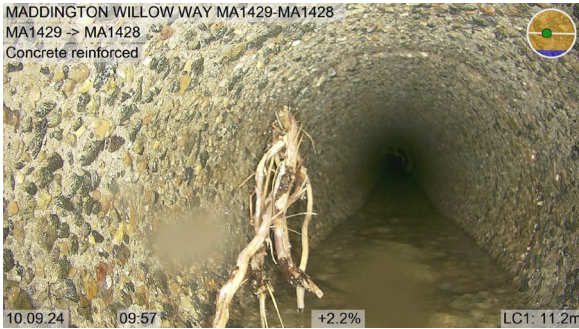
MA1429-MA1428_a05fe89a-3092-4720-a548-5f72f5b2b79f_2_0240910_095715_589.jpg, 00:07:01, 11.20
 Recently cut tap roots, a small number of cut major roots (10mm or greater) is evident, Obstruction: 20%, at joint from 7 o'clock to 10 o'clock

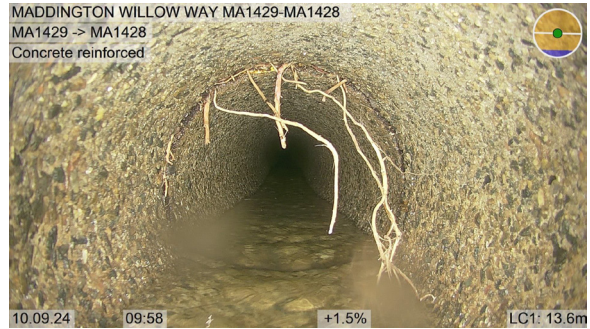
MA1429-MA1428_6f346f7b-4b3d-4e14-b05a-f59bc15156c7_2_0240910_095859_550.jpg, 00:08:31, 13.60
 Recently cut fine roots-a relatively small number of cut minor roots remain, Obstruction: 10%, at joint from 10 o'clock to 2 o'clock

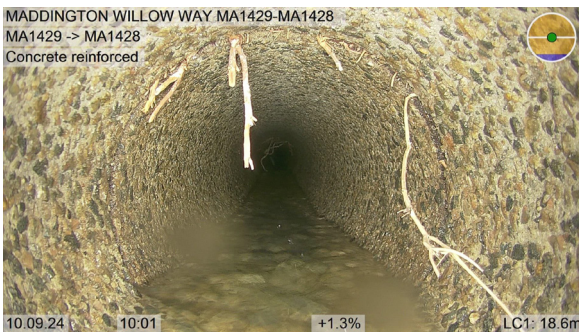
MA1429-MA1428_53558f7d-7d27-49e3-99e6-1b59f5815b5f_2_0240910_100113_097.jpg, 00:10:31, 18.60
 Recently cut fine roots-a relatively small number of cut minor roots remain, Obstruction: 10%, at joint from 10 o'clock to 2 o'clock

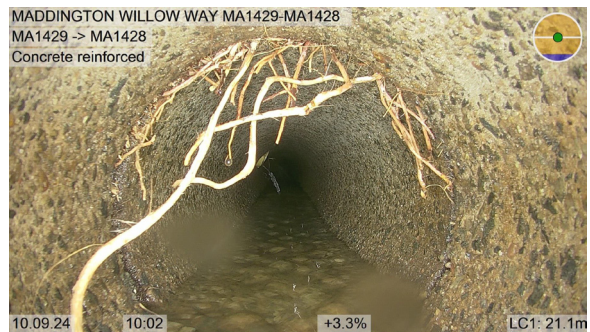
MA1429-MA1428_36046084-1a0b-47c0-932c-a0a5ad31acae_20240910_100215_836.jpg, 00:11:12, 21.10
 Recently cut interwoven mass of mostly fine roots leaving a beard of roots, Obstruction: 20%, at joint from 9 o'clock to 3 o'clock

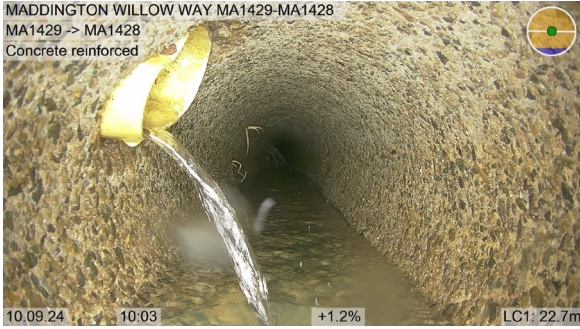
MA1429-MA1428_f1d63ef2-2b51-4b91-94d8-6f753c2a891c_20240910_100308_850.jpg, 00:11:46, 22.70
A connecting conduit is projecting into the conduit being inspected and is obstructing the cross sectional area at 10 o'clock, magnitude of intrusion: 10%

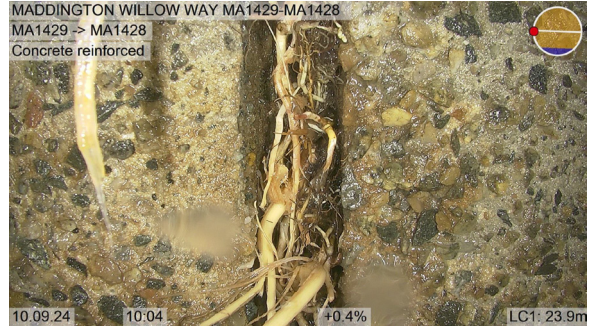
MA1429-MA1428_e0912fb9-4600-429c-af7e-9c2cccd9786a_20240910_100449_386.jpg, 00:13:12, 23.90
Recently cut interwoven mass of mostly fine roots leaving a beard of roots, Obstruction: 10%, at joint from 8 o'clock to 5 o'clock

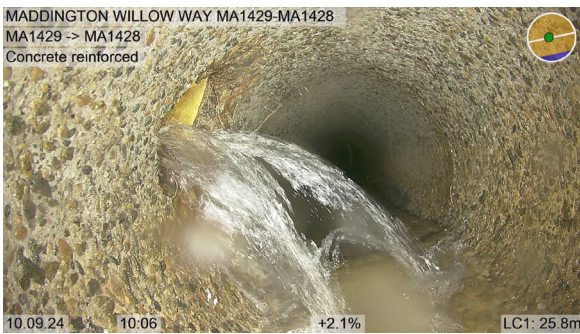
MA1429-MA1428_e49bd966-94cd-45a2-9ad9-66848dfed0ea_20240910_100641_616.jpg, 00:13:44, 25.80
Connection, unlined, connection appears to be open, Height/Diameter (mm): 90 at 10 o'clock

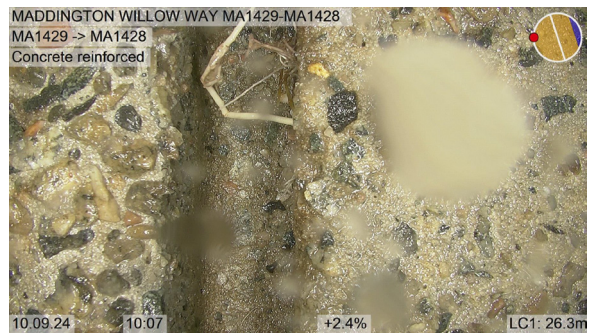
MA1429-MA1428_2b6c5210-687b-4b91-9101-a4691f2d51e8_20240910_100739_582.jpg, 00:14:30, 26.30
Joint displaced longitudinally, 20mm

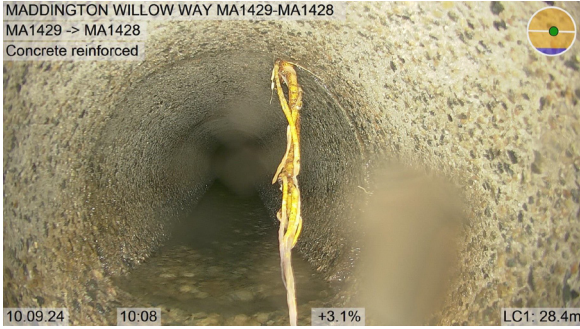
MA1429-MA1428_f41b46cf-80de-45af-8aa8-25456dc3bfc2_2
0240910_100814_200.jpg, 00:14:52, 28.40
Tap roots, reduction in cross sectional area, Obstruction: 10%,
at joint at 1 o'clock

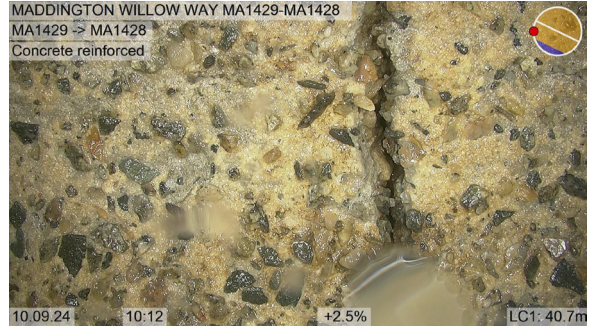
MA1429-MA1428_4f92477e-83eb-48c7-a22b-9b6af27bb95f_2
0240910_101257_512.jpg, 00:19:07, 40.70
Circumferential cracking, width: 4mm from 3 o'clock to 9
o'clock

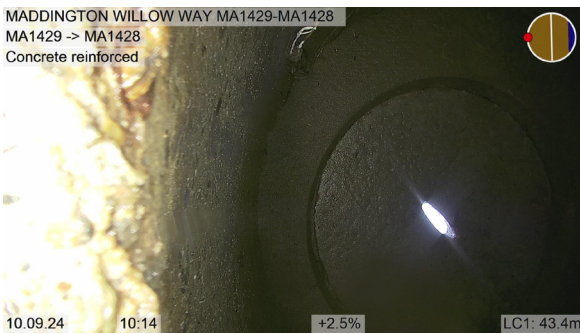
MA1429-MA1428_da65eb16-e39b-435d-a734-6d1ae6917588
_20240910_101432_836.jpg, 00:20:31, 43.40
Surface damage concrete, spalling of the concrete conduit
including localised chipping from 12 o'clock to 12 o'clock,
Finish

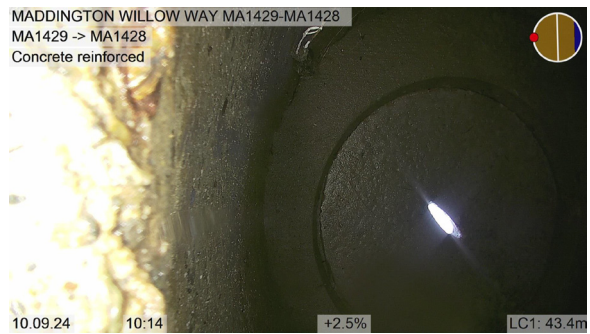
MA1429-MA1428_3002bd45-befa-4c54-b667-4618f866f53c_2
0240910_101451_674.jpg, 00:20:38, 43.40
Finish node, maintenance chamber, Nodename:, MA1428
