Geotechnical Report

**Southern River Precinct 3D
Lots 9 and 1792 Holmes Street Southern River**

January 2018

Southern River Precinct 3D

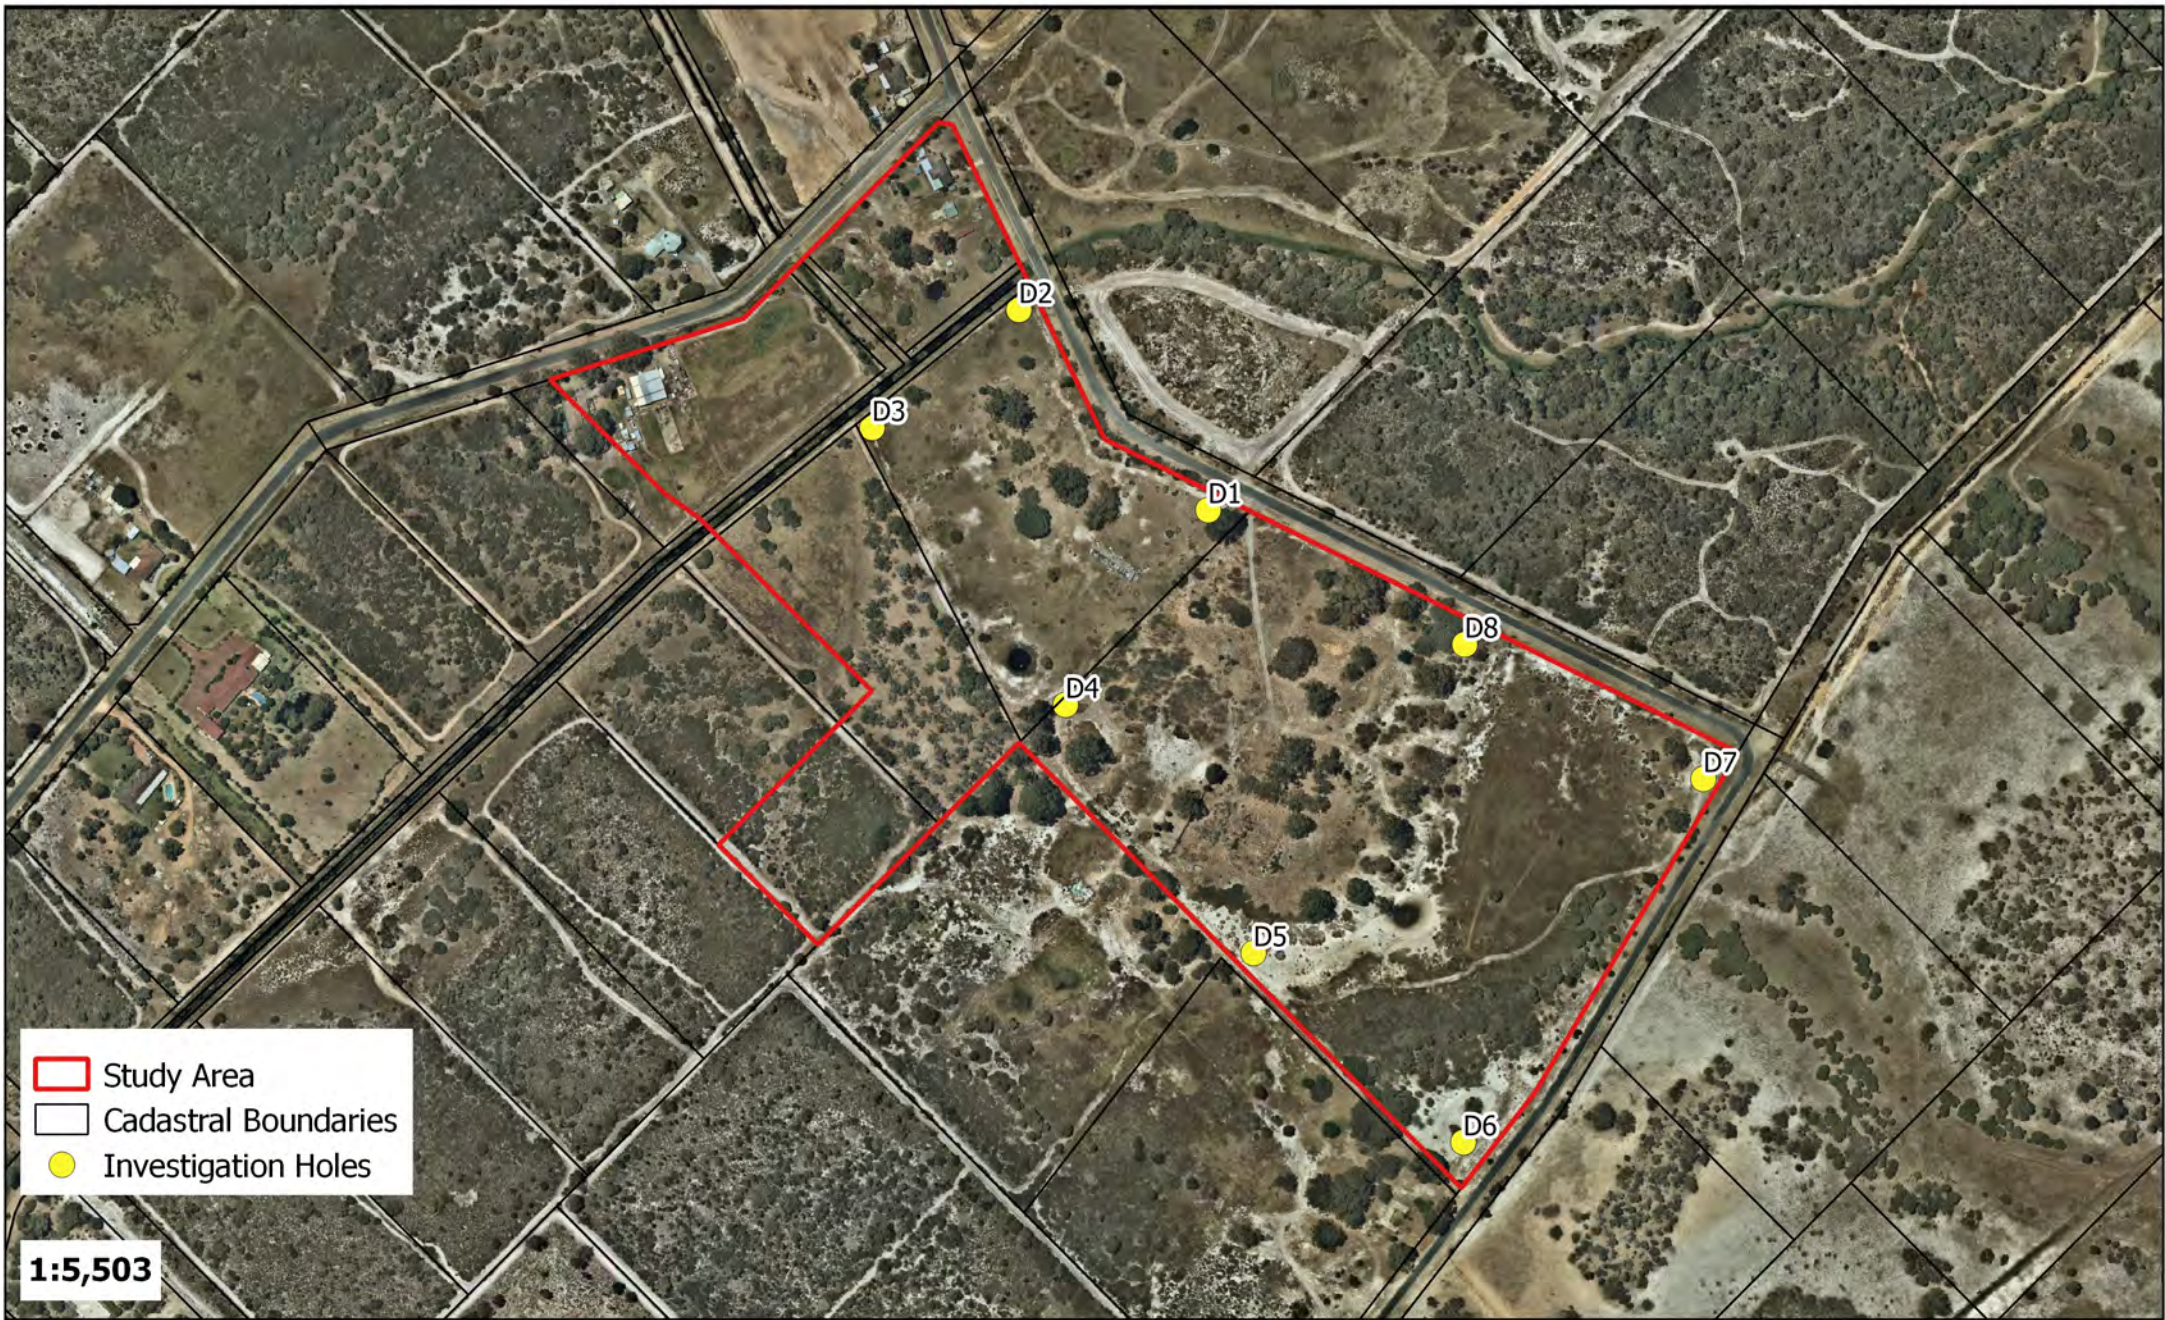
FIGURE 6. Geotechnical Investigation Locations

The site has a typical soil profile of sand over sandy clays, with a layer of weakly cemented iron rich silty sand (coffee rock) commonly found between the sand and clays.

The common soil profile was found at all boring locations except for D3, which was loamy and clayey sands all the way through the profile. The depth of sand at each location varied between 4200mm at D4 and 2250mm at D5, the sand was generally grey and white medium textured Bassendean sand. Coffee rock was intersected at all except two of the locations, D3 and D 6, and occurred at variable locations within the soil profile, most commonly at the interface between sands and clayey sands. Clayey sands are of the Guilford formation and varied from grey to brown in colour. Soil profile logs and photos can be seen in Appendix 1.

Field investigations took place in April 2011 with 8 boreholes dug using a mechanical hollow tipped auger drill rig that provides core samples of the soil profile as the hole is drilled. From the soils cores, soil profiles were logged and samples taken for laboratory analysis (Figure 6). Piezometers were installed into the drilled boreholes for groundwater investigations.

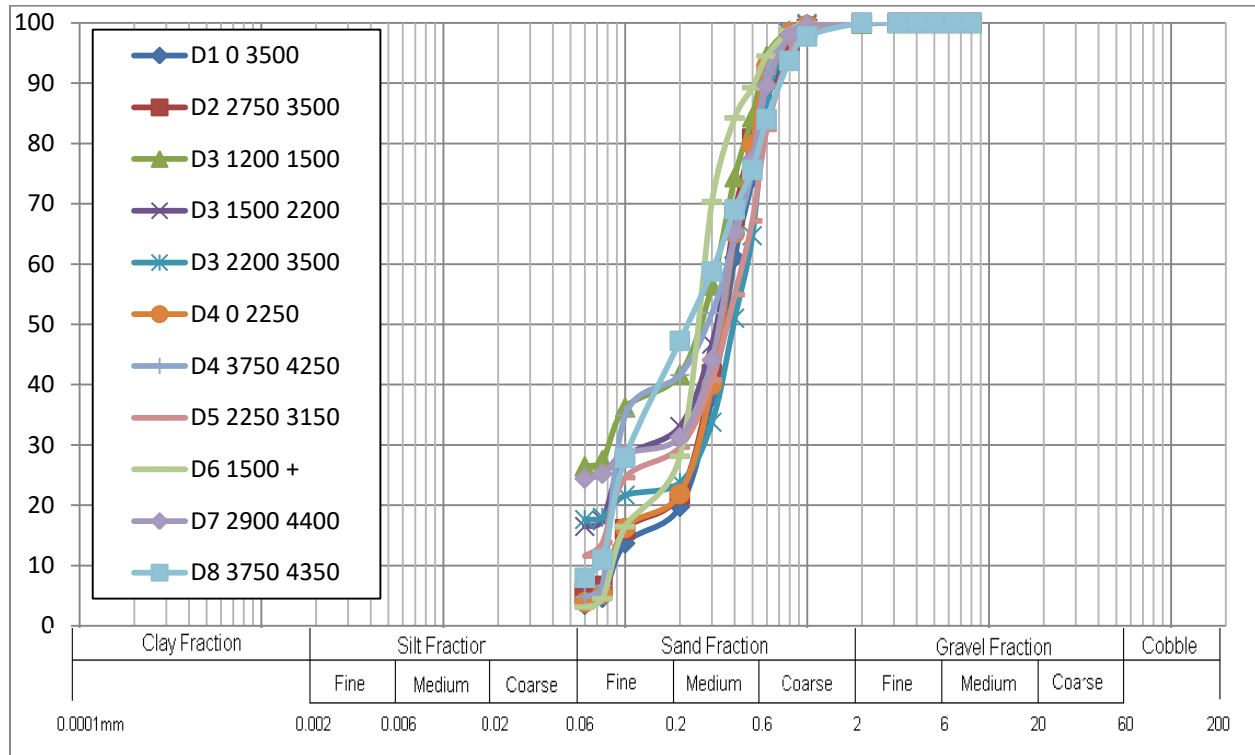
Figure 7: Particle Size Distribution Graph

Particle size distribution (PSD) was determined on soils collected during the field investigation that gave a representative example of the soils present in the soil profiles of the site. The results of the PSD analysis show that the sands on the site are generally a medium textured, poorly to uniformly sorted sand with less than 5 per cent fines (<0.075mm). The clays on the site are actually clayey sands with a fines content between 15 and 30 per cent. Graphs of PSD can be seen in figure 7.

generally poorly or uniformly sorted. The remaining three samples that underwent PSD are borderline classifications between sands and clayey sands, with two of them being closer to sands with between 5 and 8 per cent fines, and the other closer to clayey sands at 11.57 per cent fines.

The Bassendean sand surface soils have a permeability in the order of 10^{-3} and 10^{-5} m/s based on particle size distribution. This is generally suitable for onsite disposal of stormwater, however the underlying low permeability coffee rock and clays, with permeabilities between 10^{-7} and 10^{-9} m/s, mean drainage will have to be carefully considered. Fill material can be used to increase the separation to clays to ensure effective performance of soak wells and infiltration areas.

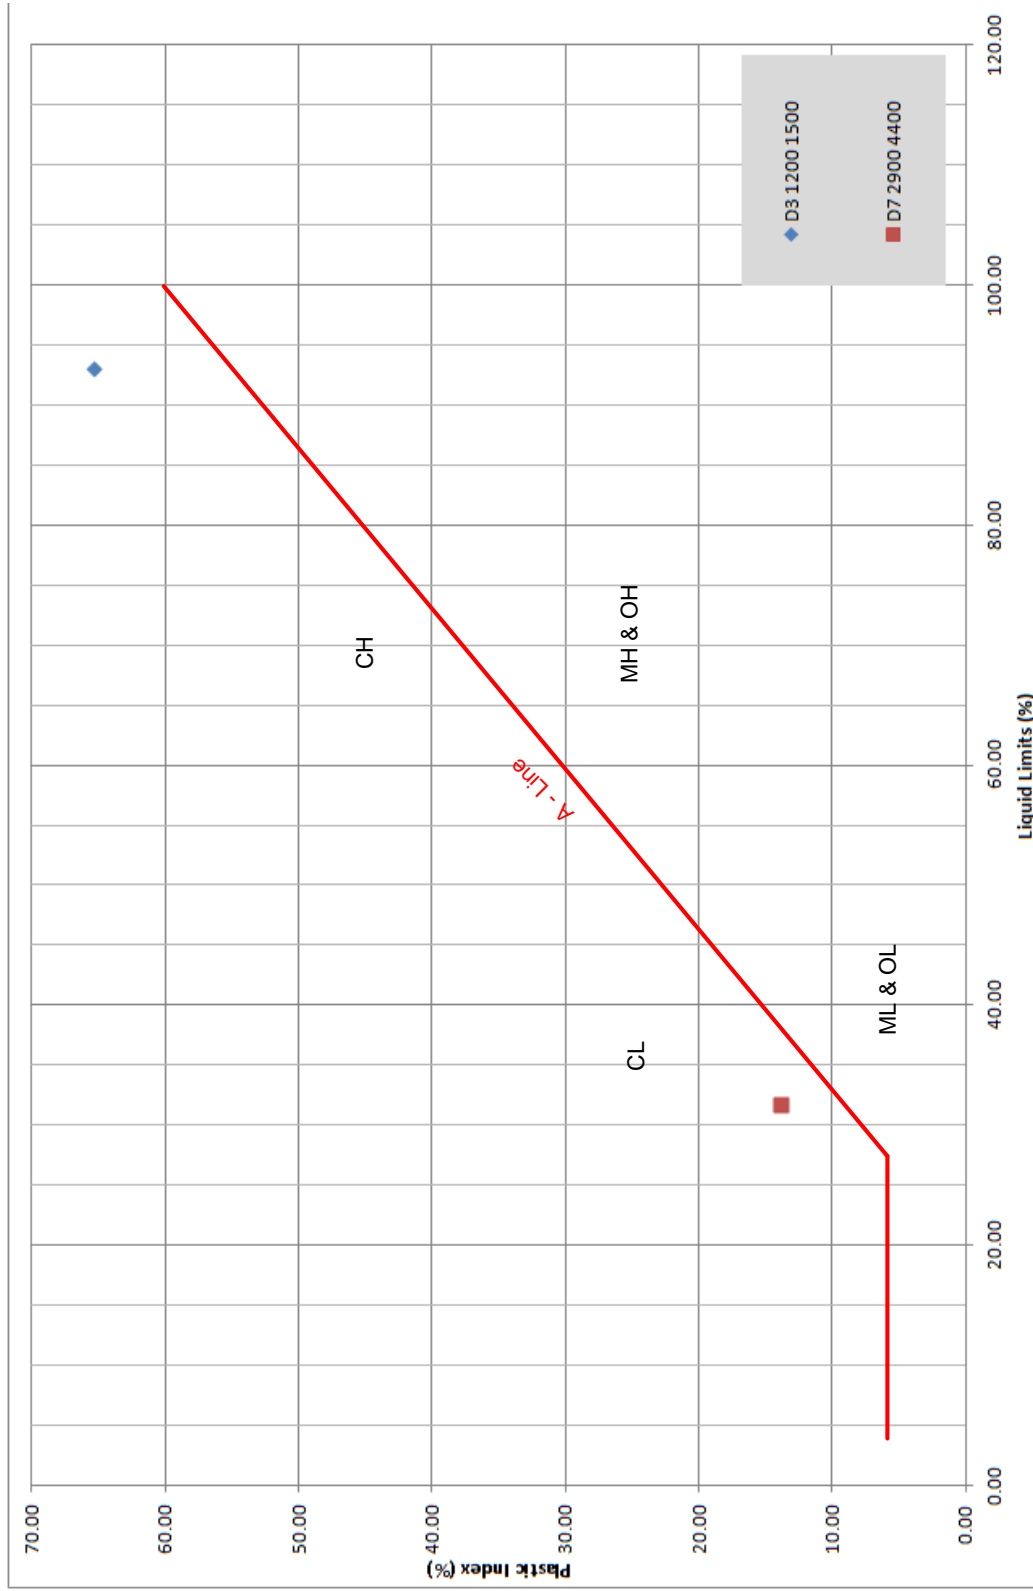
Figure 8: Atterberg Graph

These can be seen in Figure 8 where the A - Line separates soils that behave in the way of organics and silts, plotting below the A - Line, to those that are clays and plot above the A - Line. Given the fact that both soils have a high percentage of sand fraction and are classified as clayey sands, the reactivity of the clay will not cause as much ground movement as if they were more pure clays. Also the depth of the sand cover at D7 limits any impact the clay would have on the surface.

Of the two samples tested for Atterberg limits D7 2900-4400 displayed low reactivity and D3 1200-1500 displayed high reactivity. As a result of this there is likely to be minimal surface movement at D7 as a result of changes in moisture of the subsoil clays. Surface movement at D3 are likely due to the proximity of the reactive clays to the surface and the shallow depth to groundwater. Post development surface levels should be carefully considered to ensure any ground movements from clays do not detrimentally impact upon buildings.

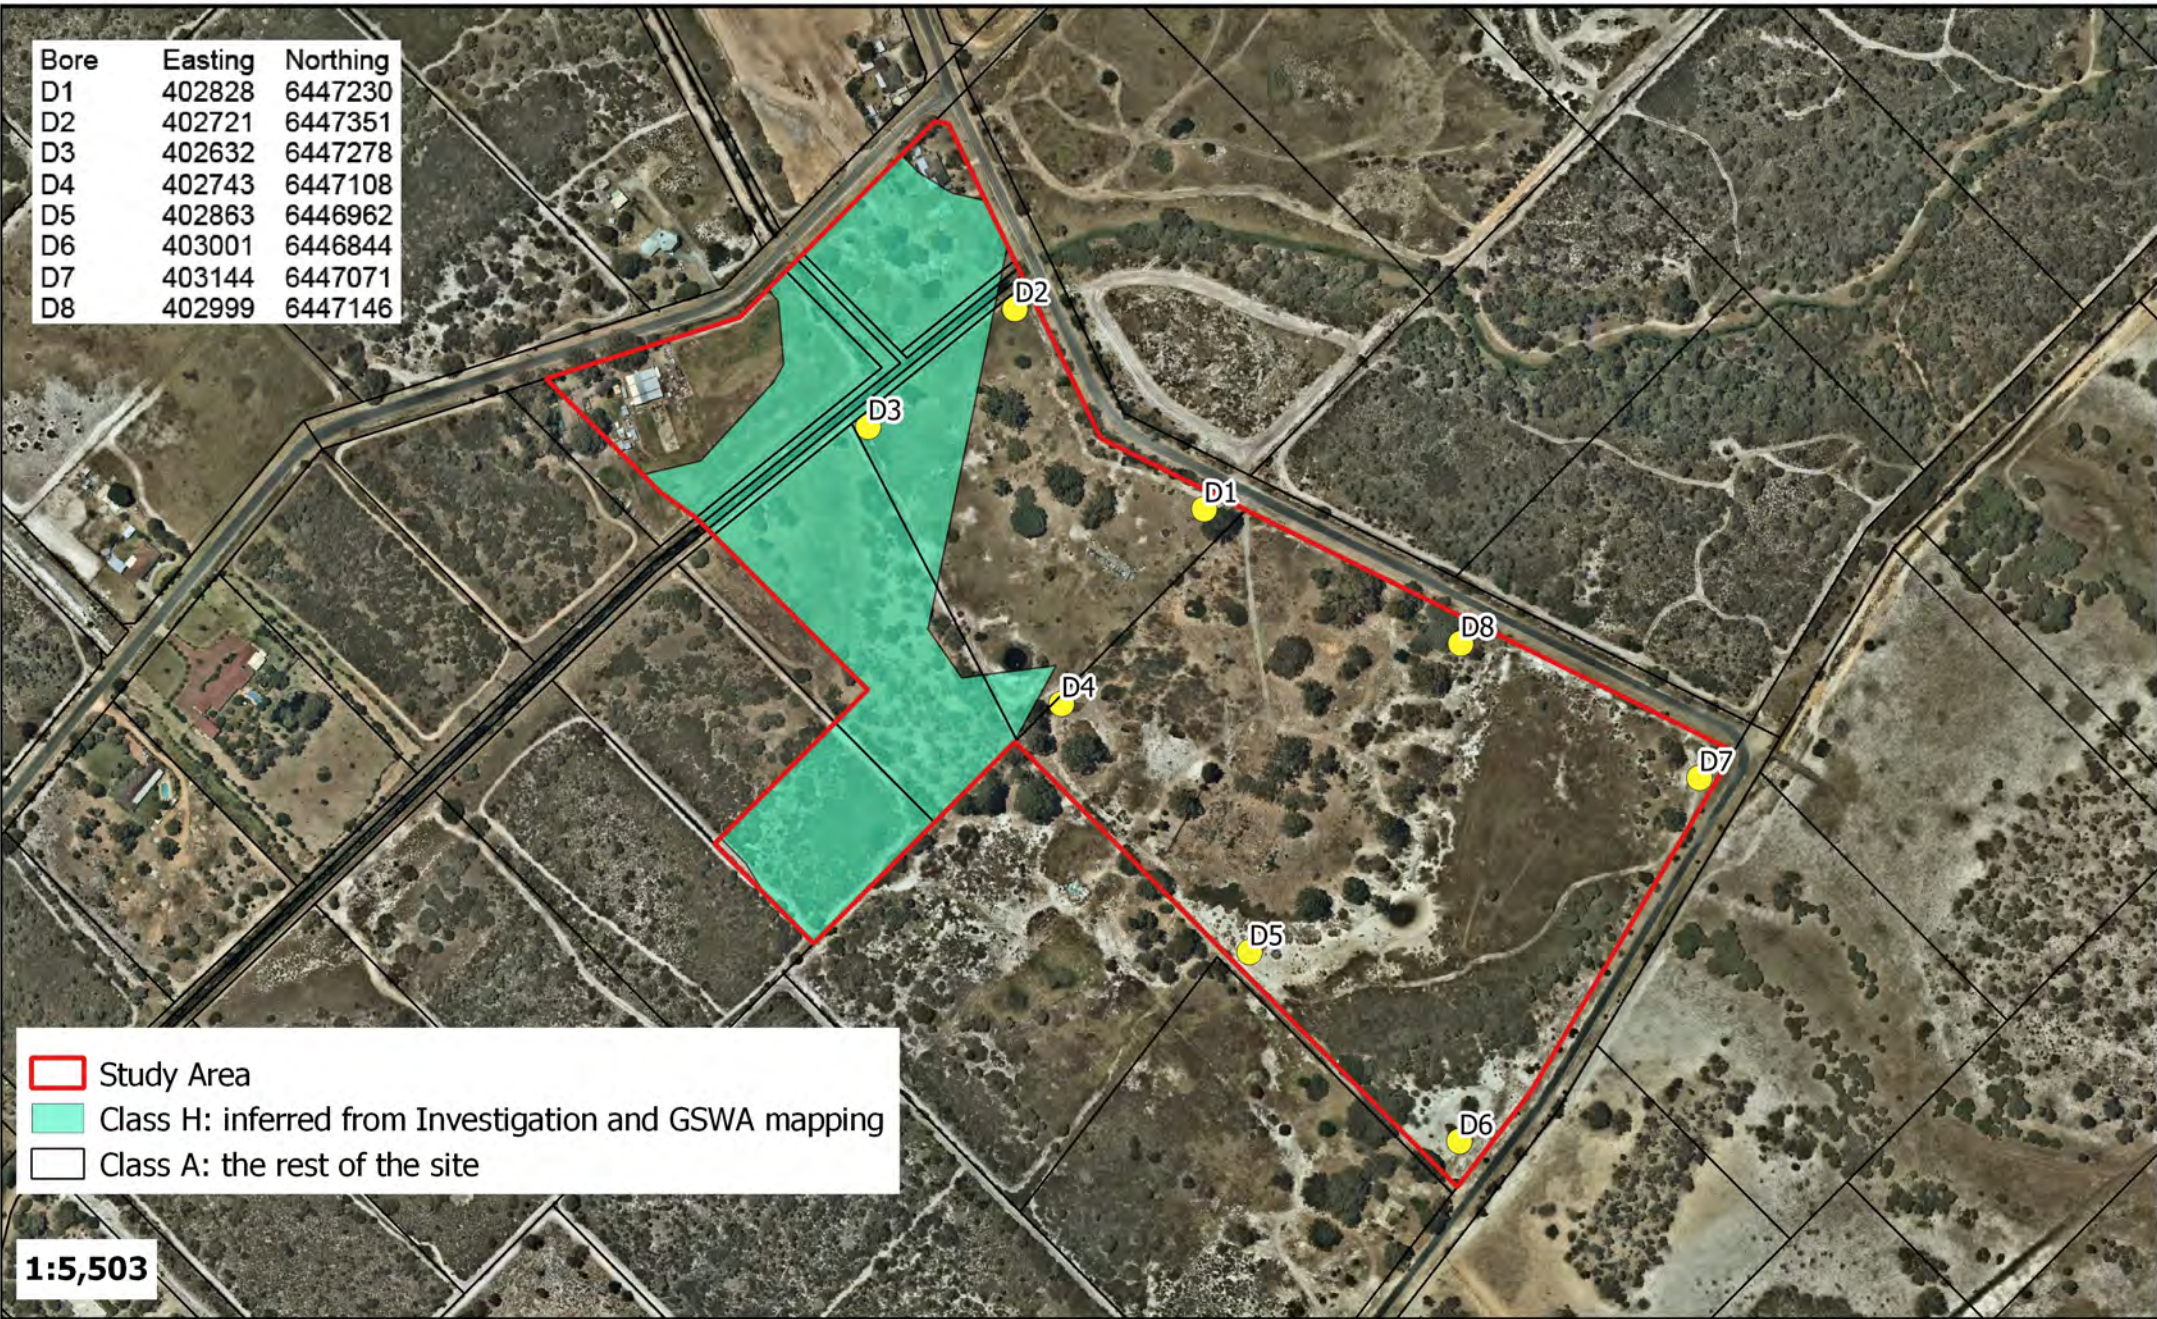
All of the site except the area around D3 (inferred from the GSWA mapping) is "Class A", as defined in the Residential Slab and Footings (Australian Standard 2870), as these areas have 1.5m or greater sand over loamy/clayey soils. Site D3 is a "Class H" classification as defined in the Residential Slab and Footings (Australian Standard 2870), as there is less than 1.5m of sand cover over the loamy/clayey soils and surface movement may result from the reactive soils due to moisture changes (Figure 9). This can be improved to a class A by the application of engineered fill to the site after the removal of the reactive clays and creation of a separation of 1.5m to the loamy/clayey soils.

Study Area
 Class H: inferred from Investigation and GSWA mapping
 Class A: the rest of the site

Further investigation of the class H area around D3 is recommended so as to determine the true extent of the reactive clays to allow determination of appropriate treatment of that area. The extent of the S10 soil type was assumed to be Class H. This should be confirmed through the excavation of more test pits in the vicinity.

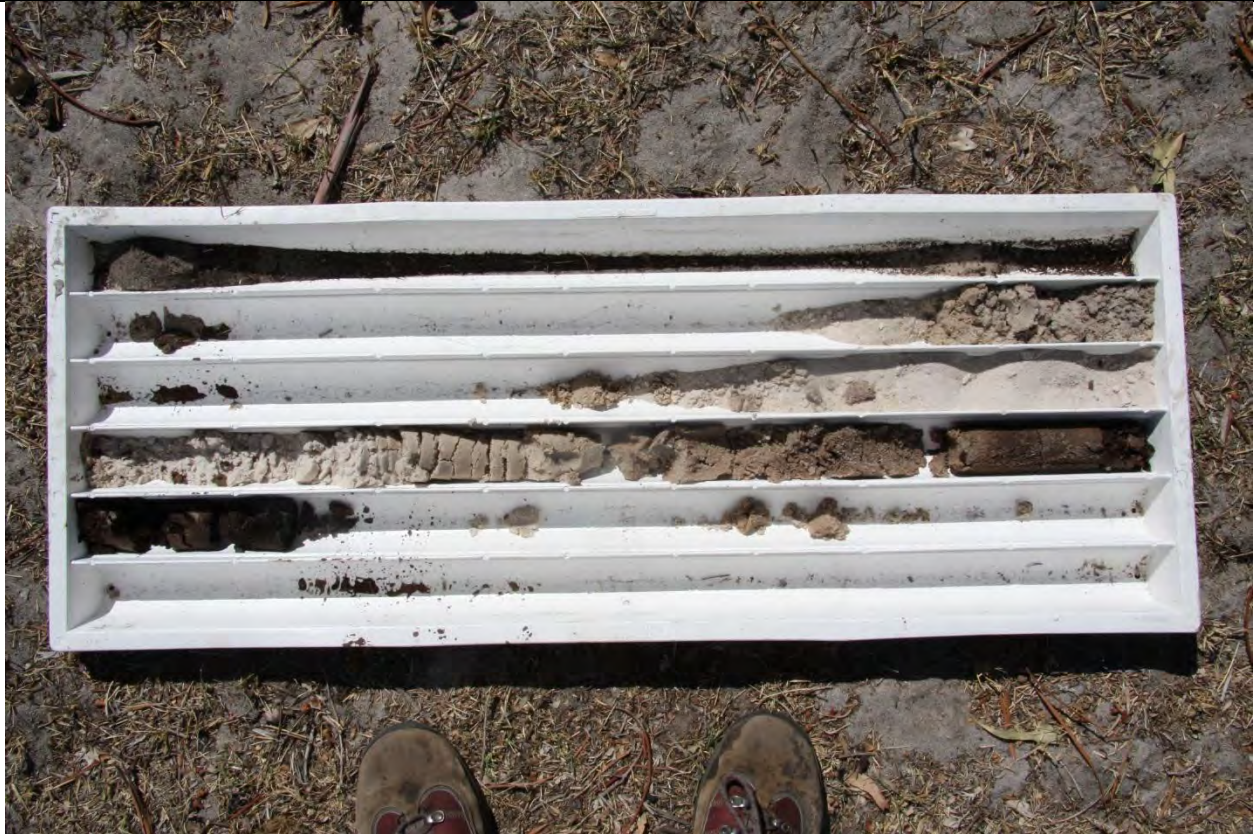
| Depth | | Type | Colour | Grade | Shape | Condition | Consistency | Structure |
|---|---|---|---|---|---|---|---|---|
| 0 | 3500 | Sand | white grey | uniform | sub rounded | dry | soft/loose | layer |
| 3500 | 3950 | Sand | grey brown | uniform | sub rounded | wet | soft/loose | layer |
| 3950 | 4200 | Sand | brown | uniform | sub rounded | wet | hard | layer |

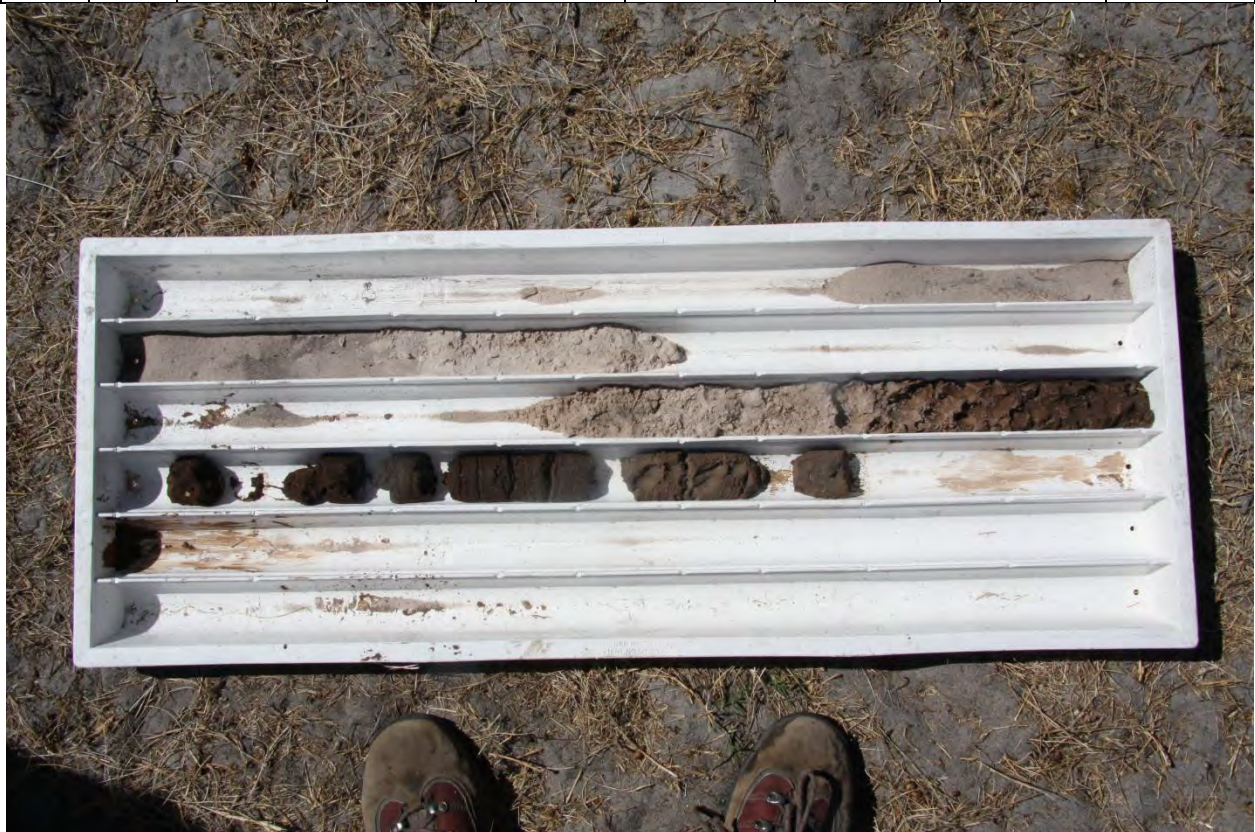
D2

| Depth | | Type | Colour | Grade | Shape | Condition | Consistency | Structure |
|---|---|---|---|---|---|---|---|---|
| 2250 | 2750 | Sand | brown | uniform | | moist | soft | layer |
| 2750 | 3500 | Sand | brown | fine uniform | | wet | hard | layer |
| 3500 | + | Clayey Sand | grey brown | well | | wet | firm | layer |

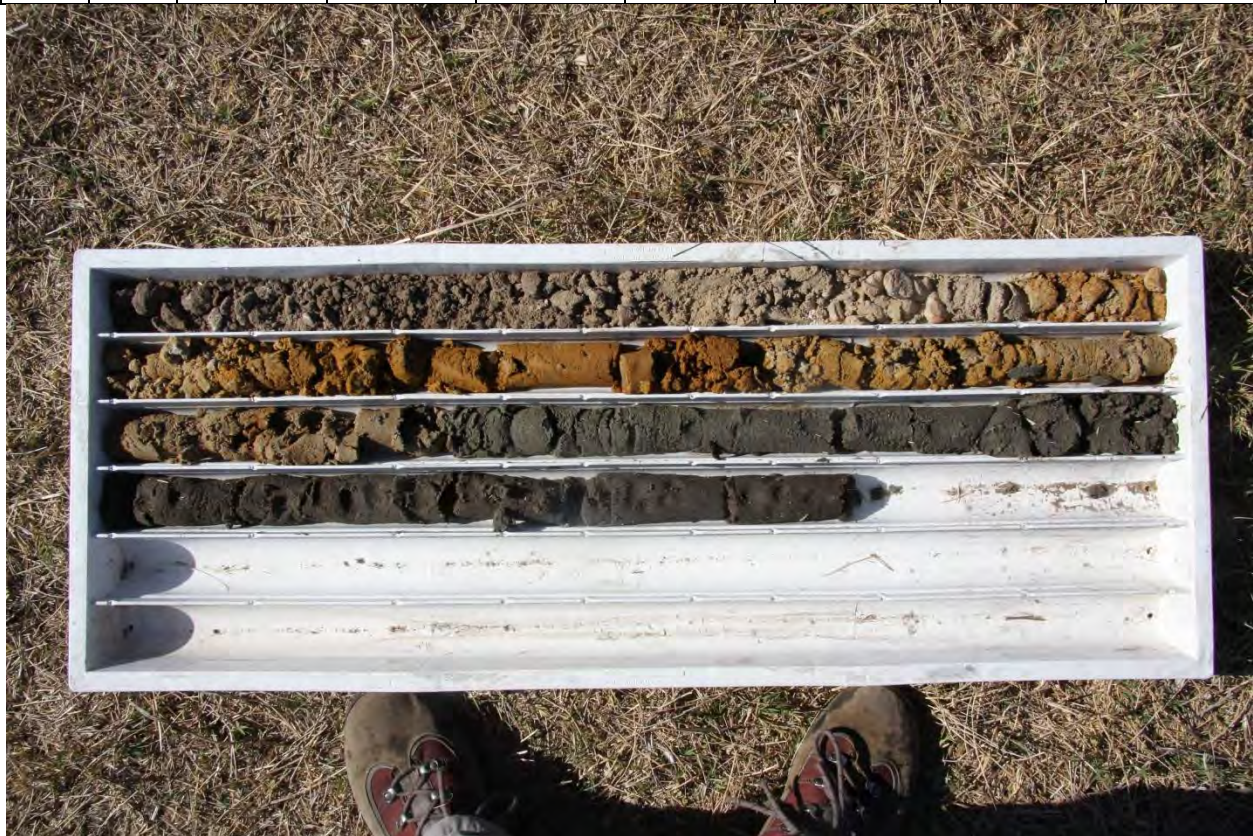
D3

| Depth | | Type | Colour | Grade | Shape | Condition | Consistency | Structure |
|---|---|---|---|---|---|---|---|---|
| 500 | 750 | loamy sand | yellow | well | | moist | firm | layer |
| 750 | 1200 | clayey sand | grey mottled orange | well | | moist | firm | layer |
| 1200 | 1500 | sandy clay | orange mottled grey | well | | moist | firm | layer |
| 1500 | 2200 | clayey sand | grey mottled orange | coarse well sorted | | moist | firm | layer |
| 2200 | 3500 | sandy clay | grey | well | | wet | firm | layer |
| 3500 | + | sandy clay | grey | fine well sorted | | wet | firm | layer |

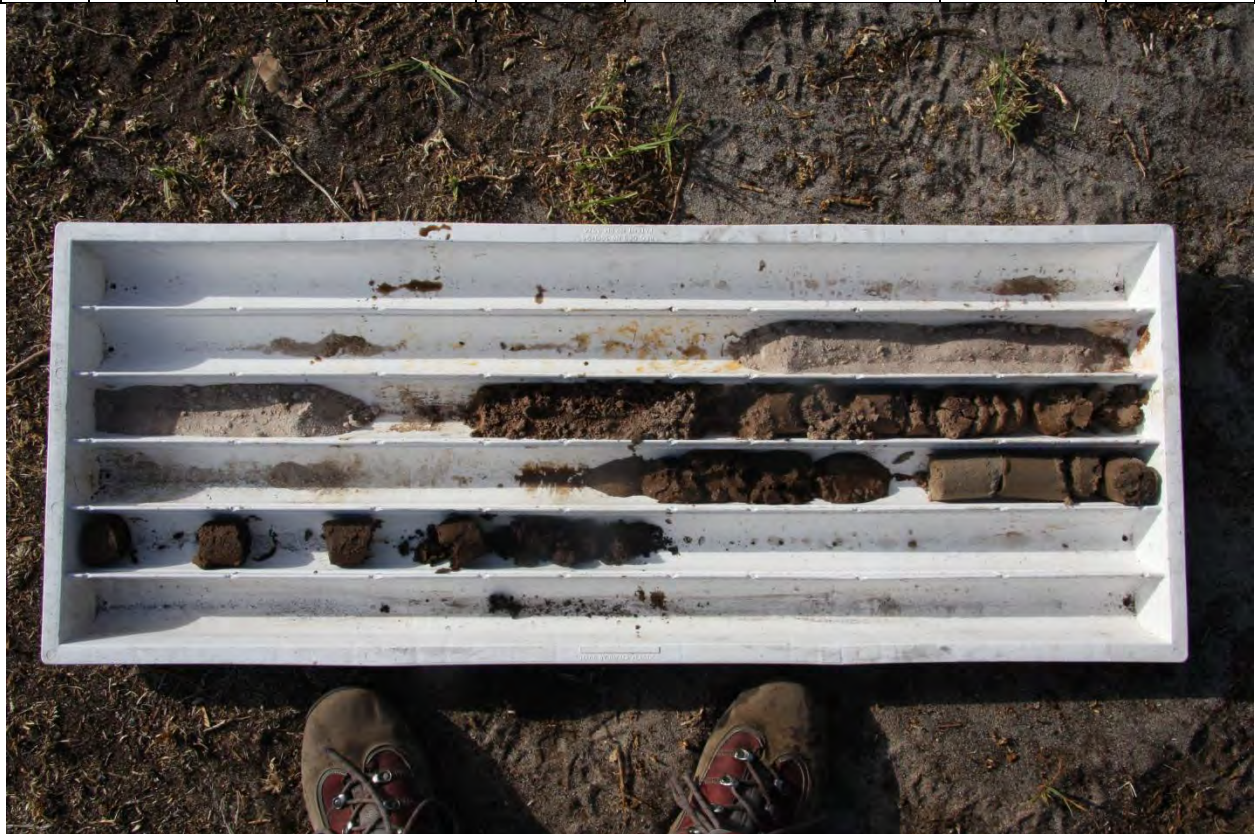
D4

| Depth | | Type | Colour | Grade | Shape | Condition | Consistency | Structure |
|---|---|---|---|---|---|---|---|---|
| 0 | 2250 | Sand | grey | unifrom | | dry | soft/ loose | layer |
| 2250 | 2500 | Sand | brown | fine uniform | | moist | soft | layer |
| 2500 | 3000 | Sand | grey brown | unifrom | | moist | soft | layer |
| 3750 | 4250 | Sand | grey brown | | | wet | soft | layer |
| 4250 | + | Sand | brown | | | wet | firm | layer |

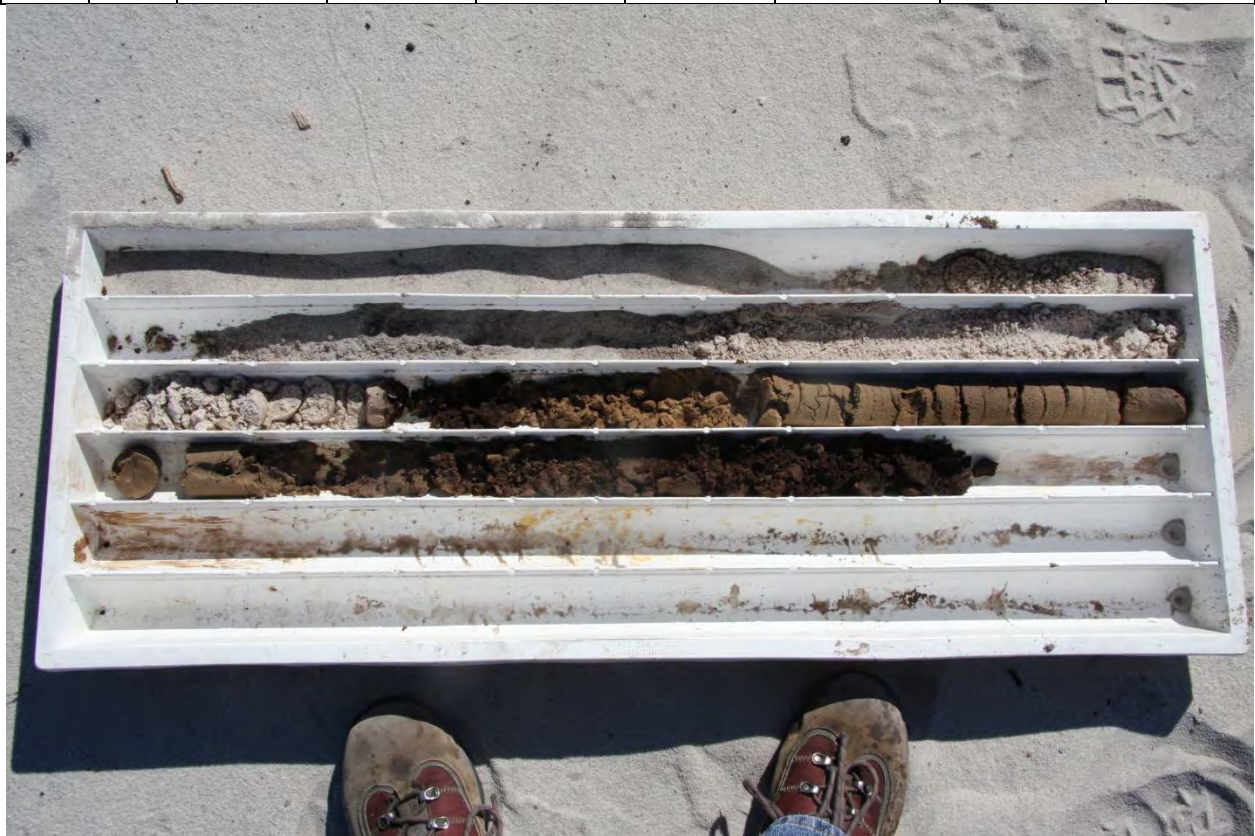
D5

| Depth | | Type | Colour | Grade | Shape | Condition | Consistency | Structure |
|---|---|---|---|---|---|---|---|---|
| 2550 | 3150 | silty sand | light brown | fine uniform | | wet | soft | layer |
| 3150 | + | silty sand | white | poorly sorted | | wet | hard | layer |

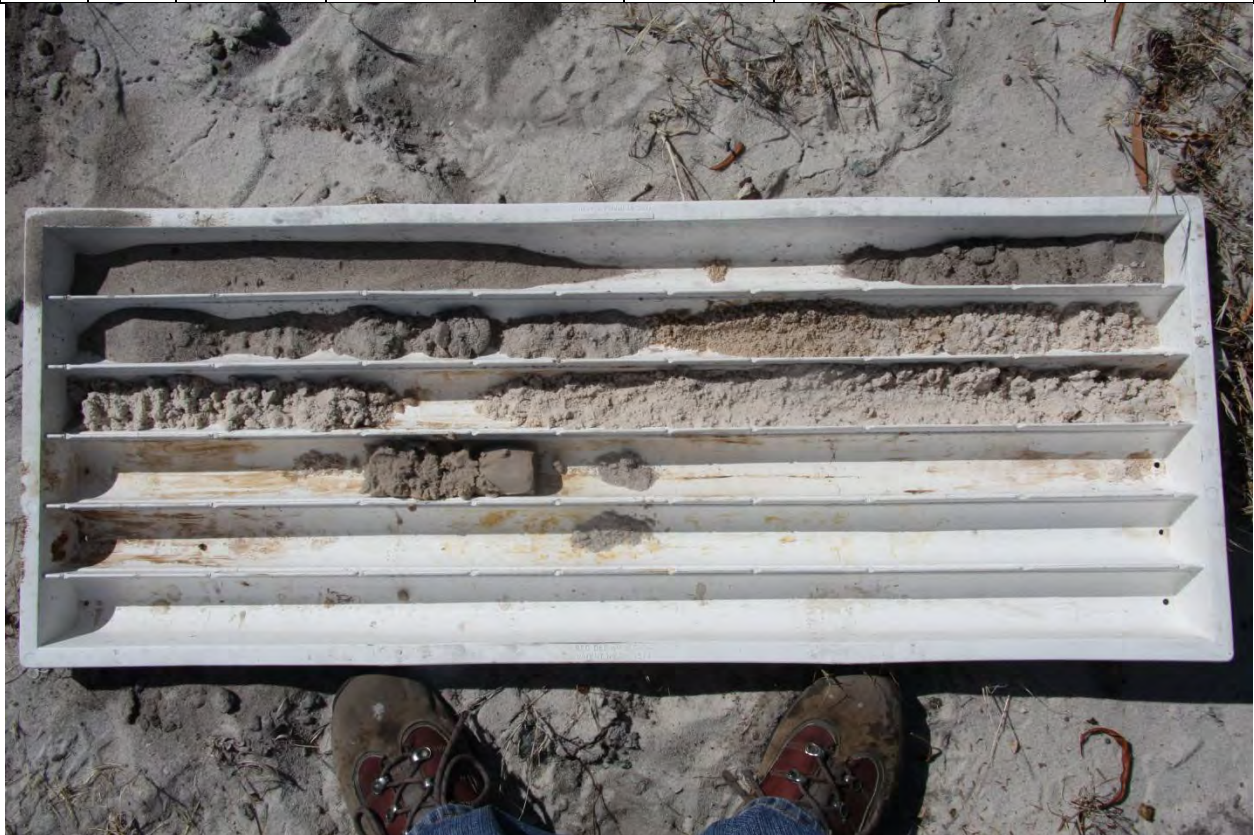
D6

| Depth | | Type | Colour | Grade | Shape | Condition | Consistency | Structure |
|---|---|---|---|---|---|---|---|---|
| 0 | 1500 | Sand | grey white | unifrom | sub rounded | dry | soft/loose | layer |
| 1500 | + | Sand | white | unifrom | sub rounded | moist to wet | soft | layer |

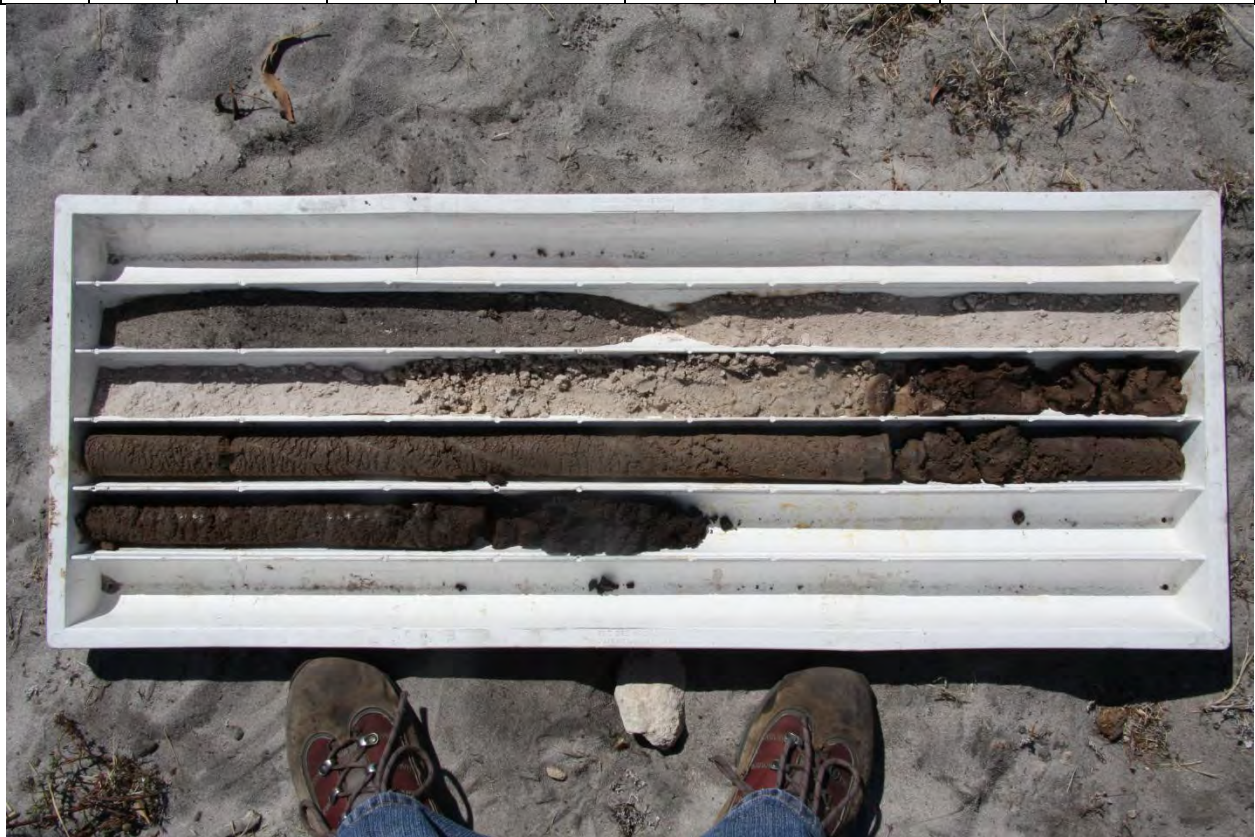
D7

| Depth | | Type | Colour | Grade | Shape | Condition | Consistency | Structure |
|---|---|---|---|---|---|---|---|---|
| 0 | 1500 | Sand | dark grey | uniform | | dry | soft/loose | layer |
| 1500 | 2750 | Sand | off white | uniform | | moist | soft/loose | layer |
| 2750 | 2900 | silty sand | brown | poor | | moist | firm | layer |
| 2900 | 4400 | sandy clay | brown | well | | moist | firm | layer |
| 4400 | + | silty sand | brown | poor | | wet | firm | layer |

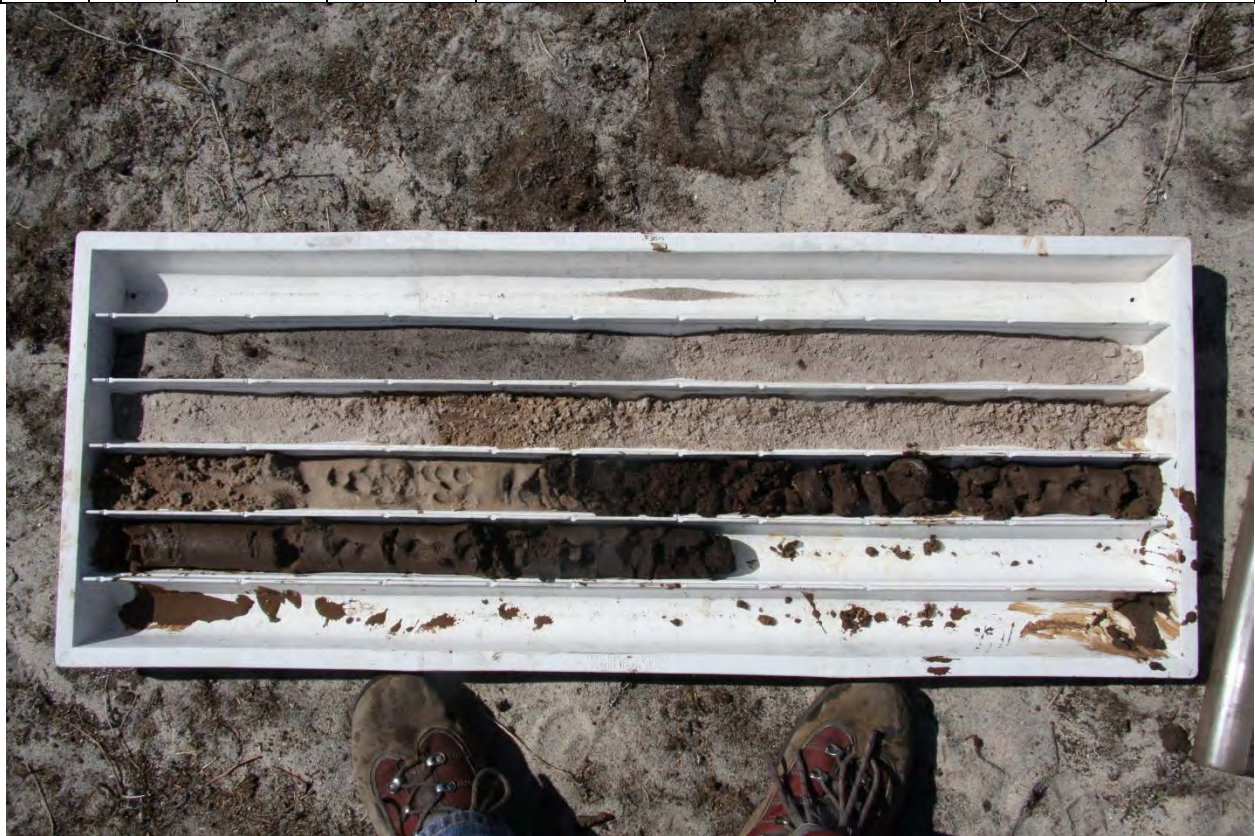
D8

| Depth | | Type | Colour | Grade | Shape | Condition | Consistency | Structure |
|---|---|---|---|---|---|---|---|---|
| 0 | 1500 | Sand | grey | uniform | | dry | soft/loose | layer |
| 1500 | 3450 | Sand | light yellow brown | uniform | | damp | soft/loose | layer |
| 3700 | 4350 | Sandy clay | brown | well | | wet | firm | layer |
| 4350 | + | silty sand | brown | well | | wet | firm | layer |

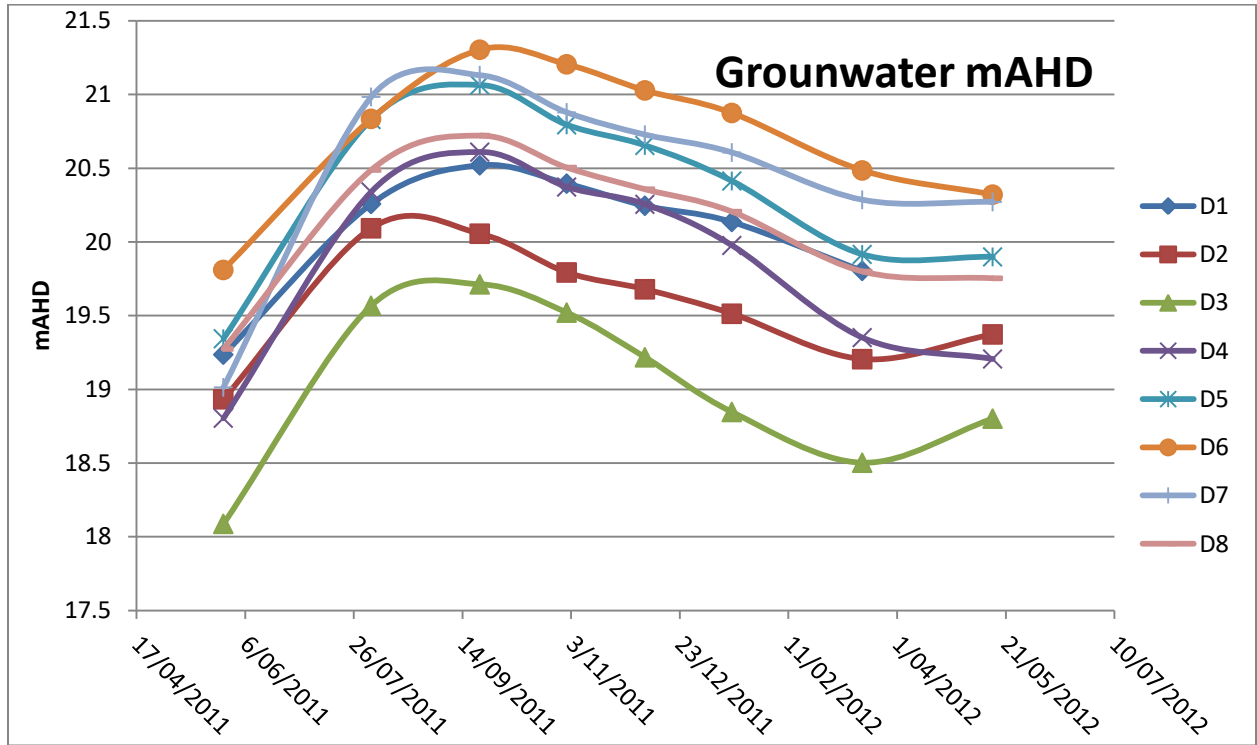
Appendix 2: Groundwater Monitoring Data

Groundwater conditions at the site have been assessed through the use of piezometers installed during drilling and collection of soil cores. Groundwater has since been monitored on a regular basis to determine seasonal fluctuations in groundwater levels and how they may impact upon development of the site. Groundwater at the site has occurs between 0.7 and 2.6 metres below ground level and has a seasonal fluctuation of up to 2m. Groundwater levels can be seen in Appendix 2. Given that the Forrestdale Main Drain runs through the site it will have a lowering effect on the groundwater of the site when the groundwater rises and intersects the level of the drain.
